Wetlands and Waters Delineation Report

July 2024
Puerto Verde Global Trade Bridge Project

Prepared for Puerto Verde Holdings, LLC

Prepared by
Anchor QEA
1217 Highway 35 South
Rockport, Texas 78382

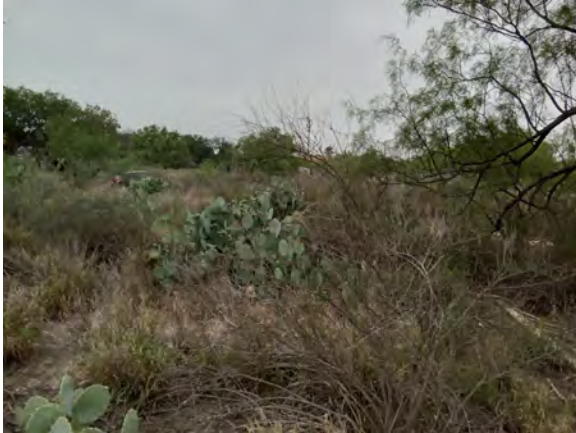
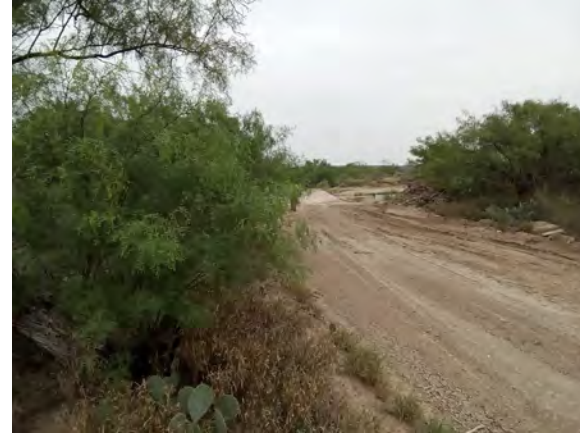
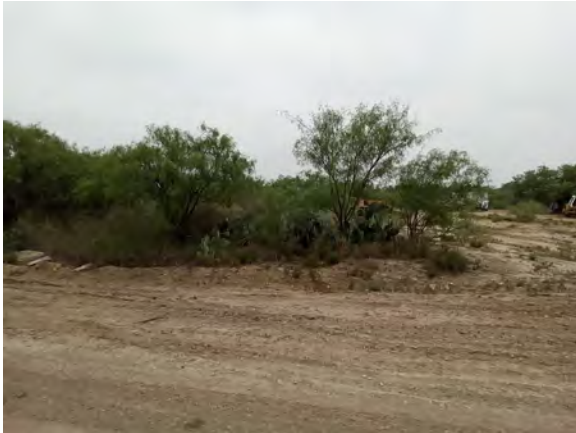
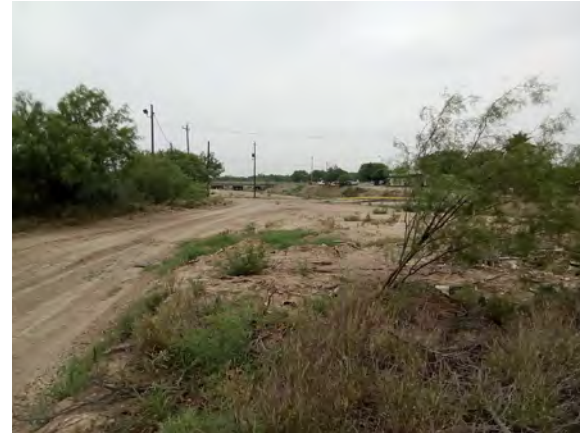
ASP01

| Remarks: Sample point recorded slightly outside of the survey area to assess conditions that appear similar to portions of the property where right-of-entry could not be obtained. Sample point recorded at a higher elevation than the adjacent Seco Creek stream bed. Sample point determined to be located within scrub-shrub uplands. | |

Hydric soil components were not observed at this sample point. A hard clay layer was encountered at 12 inches below the soil surface.

Surface Soil Cracks (B6) were observed at this sample point. Surface Soil Cracks (B6) are classified as a secondary wetland hydrology indicator and do not fulfill the wetland hydrology requirement at this sample point.

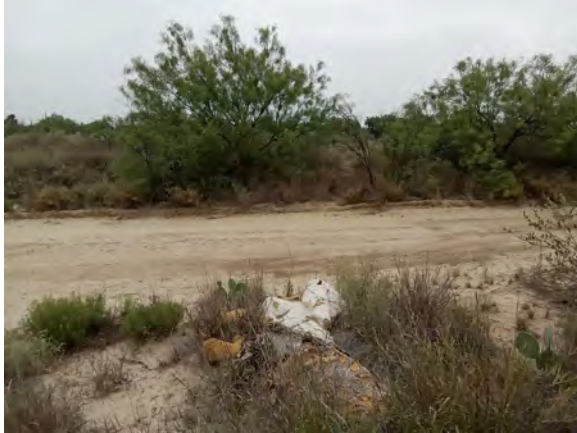
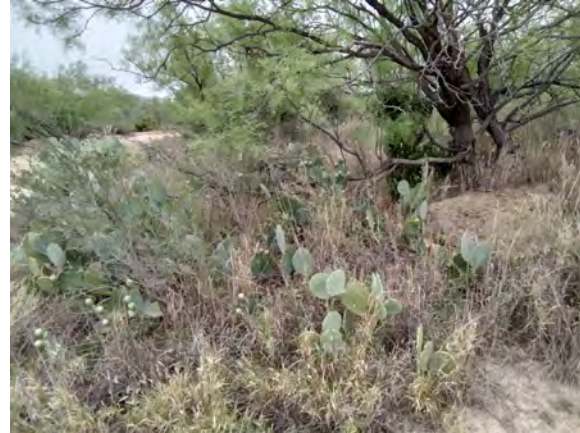
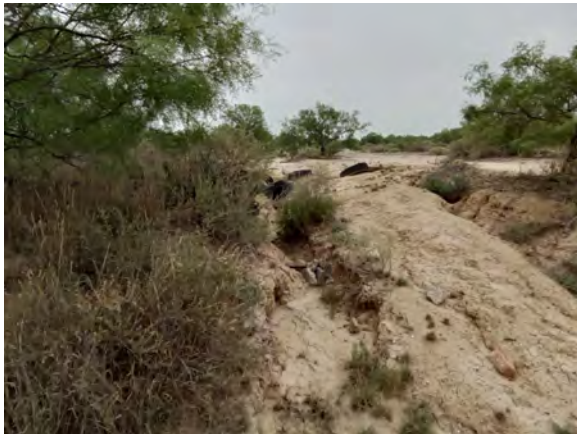
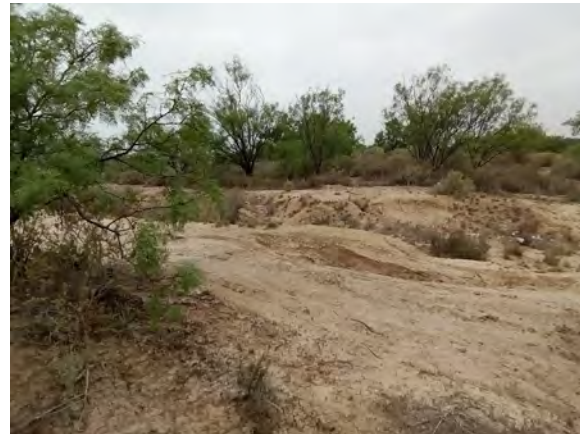
ASP02

| Remarks: Sample point recorded in scrub-shrub upland habitat adjacent to an unimproved road. Minor evidence of erosion was observed in the vicinity but area is otherwise comprised of upland habitat. | |

Remarks:
Hydric soil characteristics were not observed at this sample point. A hard clay layer was encounter at 12 inches below the soil surface.

Remarks:
Surface Soil Cracks (B6) were observed at this sample point. Surface Soil Cracks (B6) are classified as a secondary wetland hydrology indicator and do not fulfill the wetland hydrology requirement at this sample point.

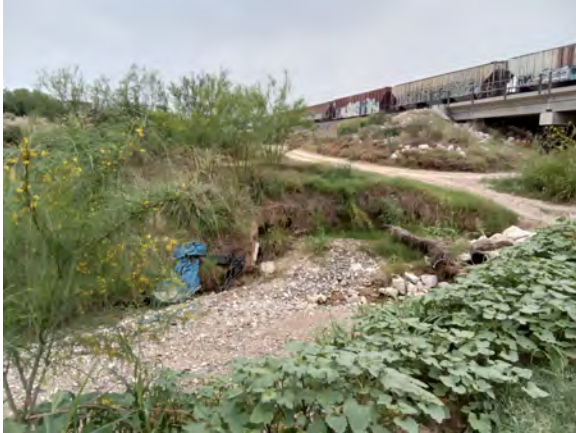
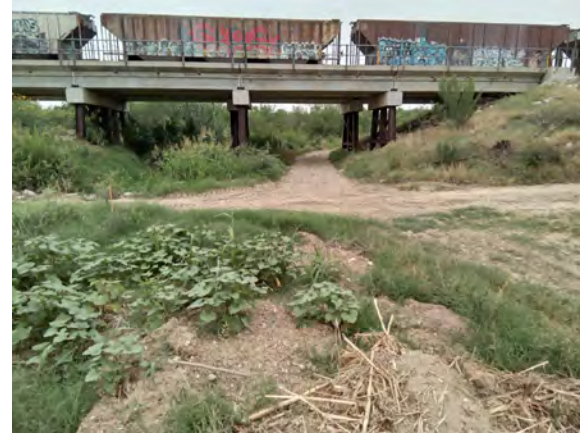
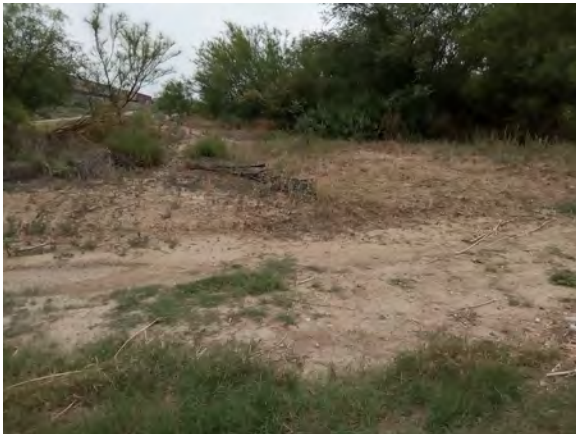
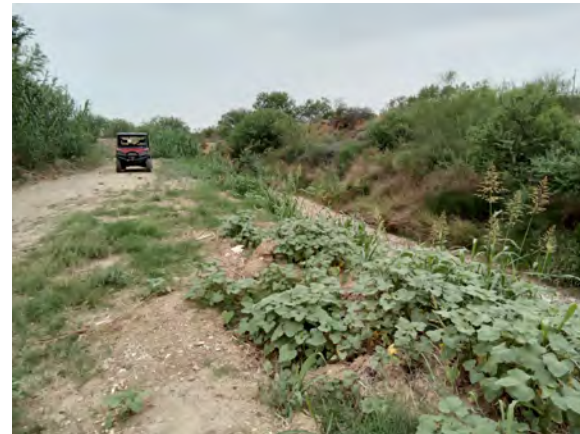
ASP03

Hydric soil components were not observed at this sample point.

Wetland hydrology was not observed at this sample point.

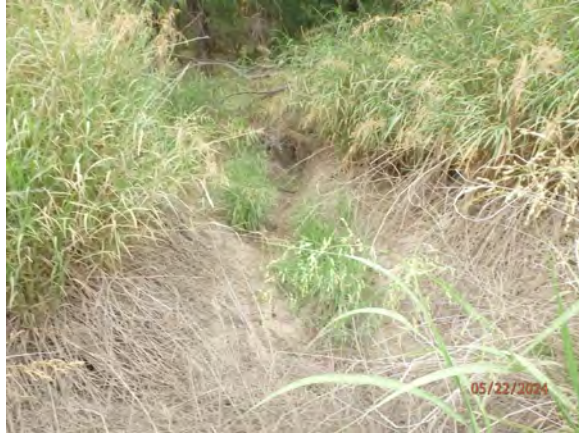
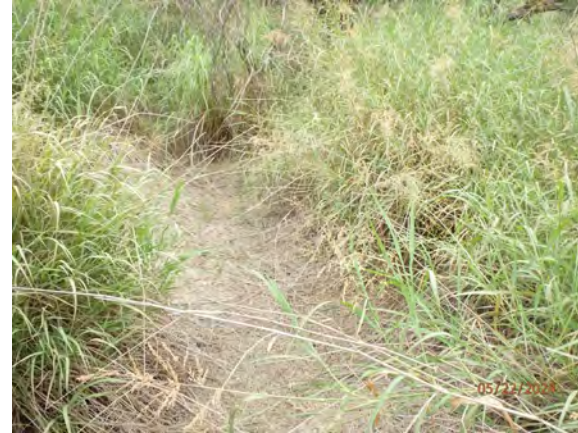
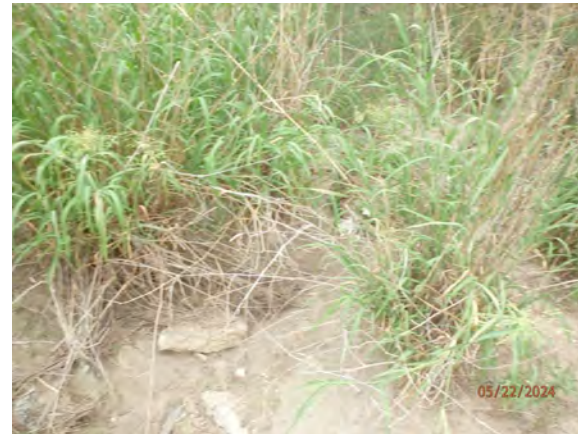
ASP04

| Remarks: This sample point was recorded to represent an upland area dominated by grasses within Mesquite dominated wooded uplands. Sample point located within a depressional landform but does not exhibit wetland conditions or any continuous surface connection to the surface tributary system. This sample point was recorded to verify this as an upland area. | |

Hydric soil characteristics were not observed at this sample point.

Wetland hydrology was not observed at this sample point.

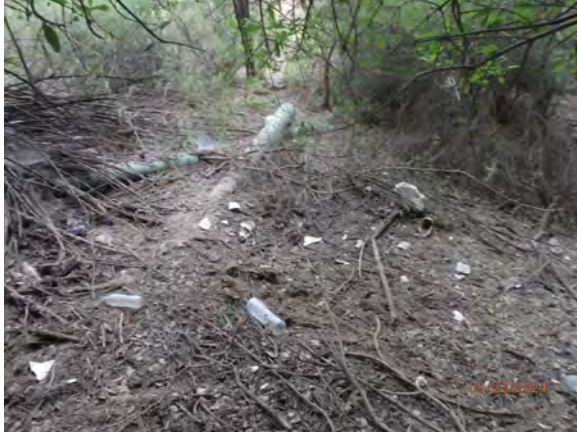
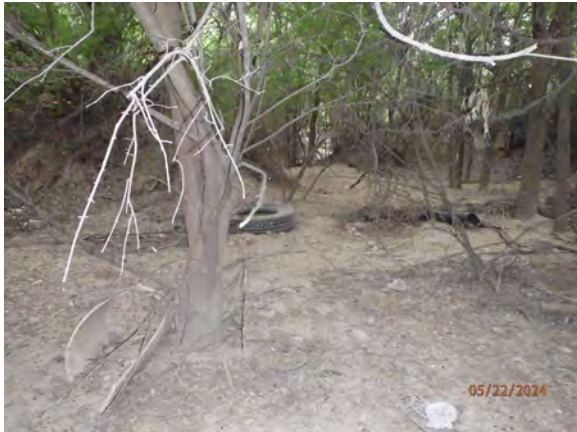
ASP05

Hydric soil components were not observed at this sample point. A hard layer of clay was encountered at 10 inches below the soil surface.

Wetland hydrology indicators were observed in the form of Drift Deposits (B3) and Drainage Patterns (B10).
